# Case Study: Lake Rehabilitation Project

| Case Study | Lake Rehabilitation Project |
| Location | Northern Greece |
| Target | Water Quality & Odour Control |

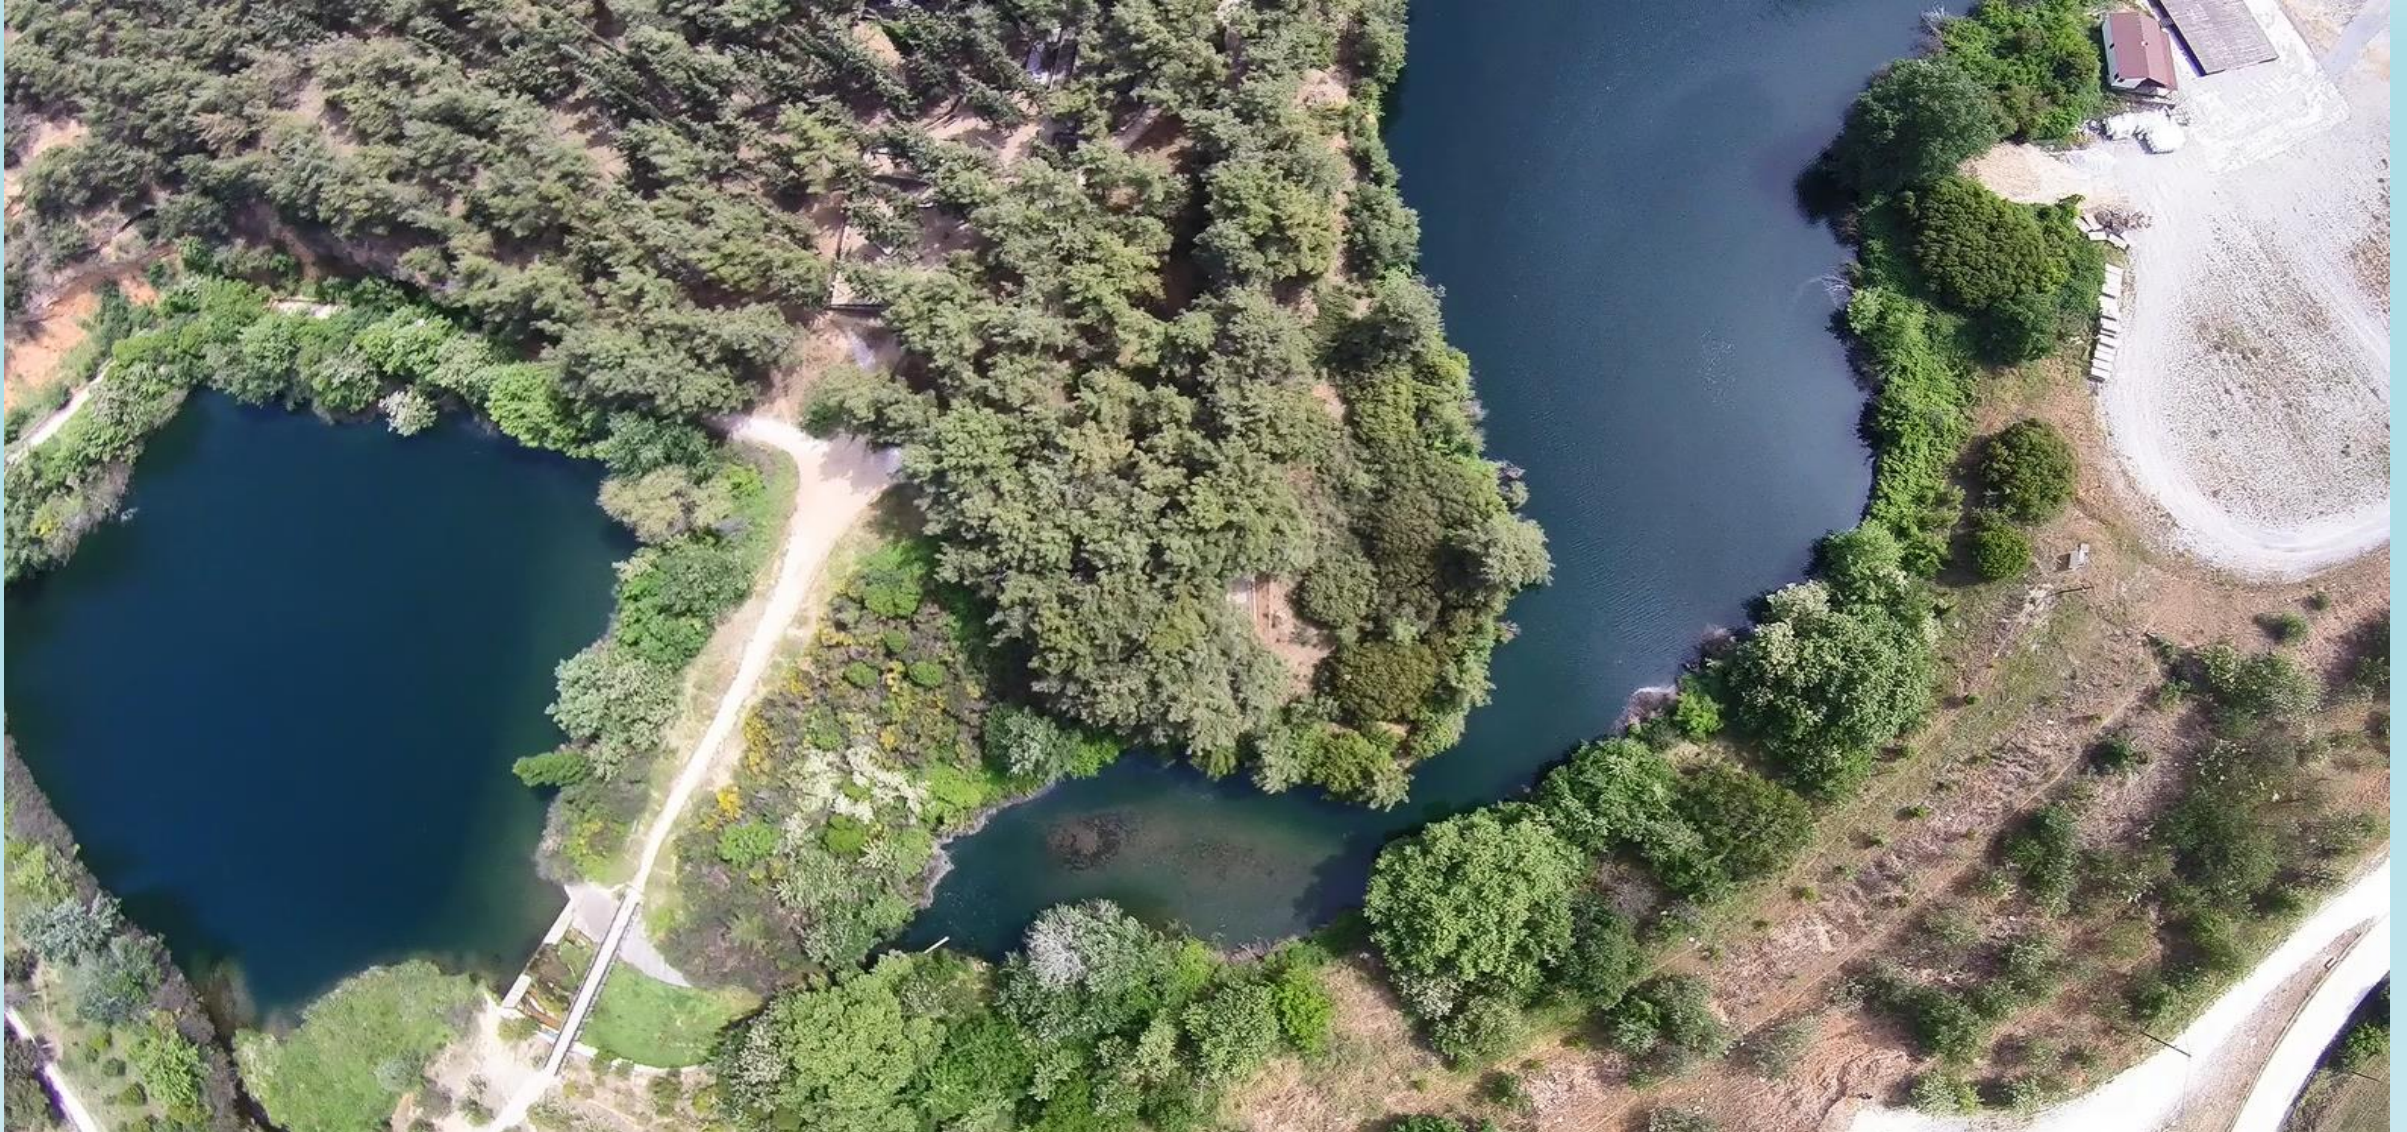
## Lake 1 & 2 – After

- ☐ The overall implementation was successful in the rehabilitation of the two lakes which were polluted with stored organic load for many years.
- ☐ The odours in the surroundings were eliminated and the water clarity was improved which was confirmed by hundreds of daily visitors.

- ☐ The Turbidity in both lakes had a decreasing tendency throughout the trial period. However, some increased values are due to rainfall which increased the incoming flows.
